RESTORING THE ROOKERY BAY ESTUARY

Rookery Bay Watershed Engineering Research Project

Task 3.7 – Addendum to the SAV Trend Summary Technical Memorandum (2/14)

Prepared for Rookery Bay National Estuarine Research Reserve
June 19, 2015

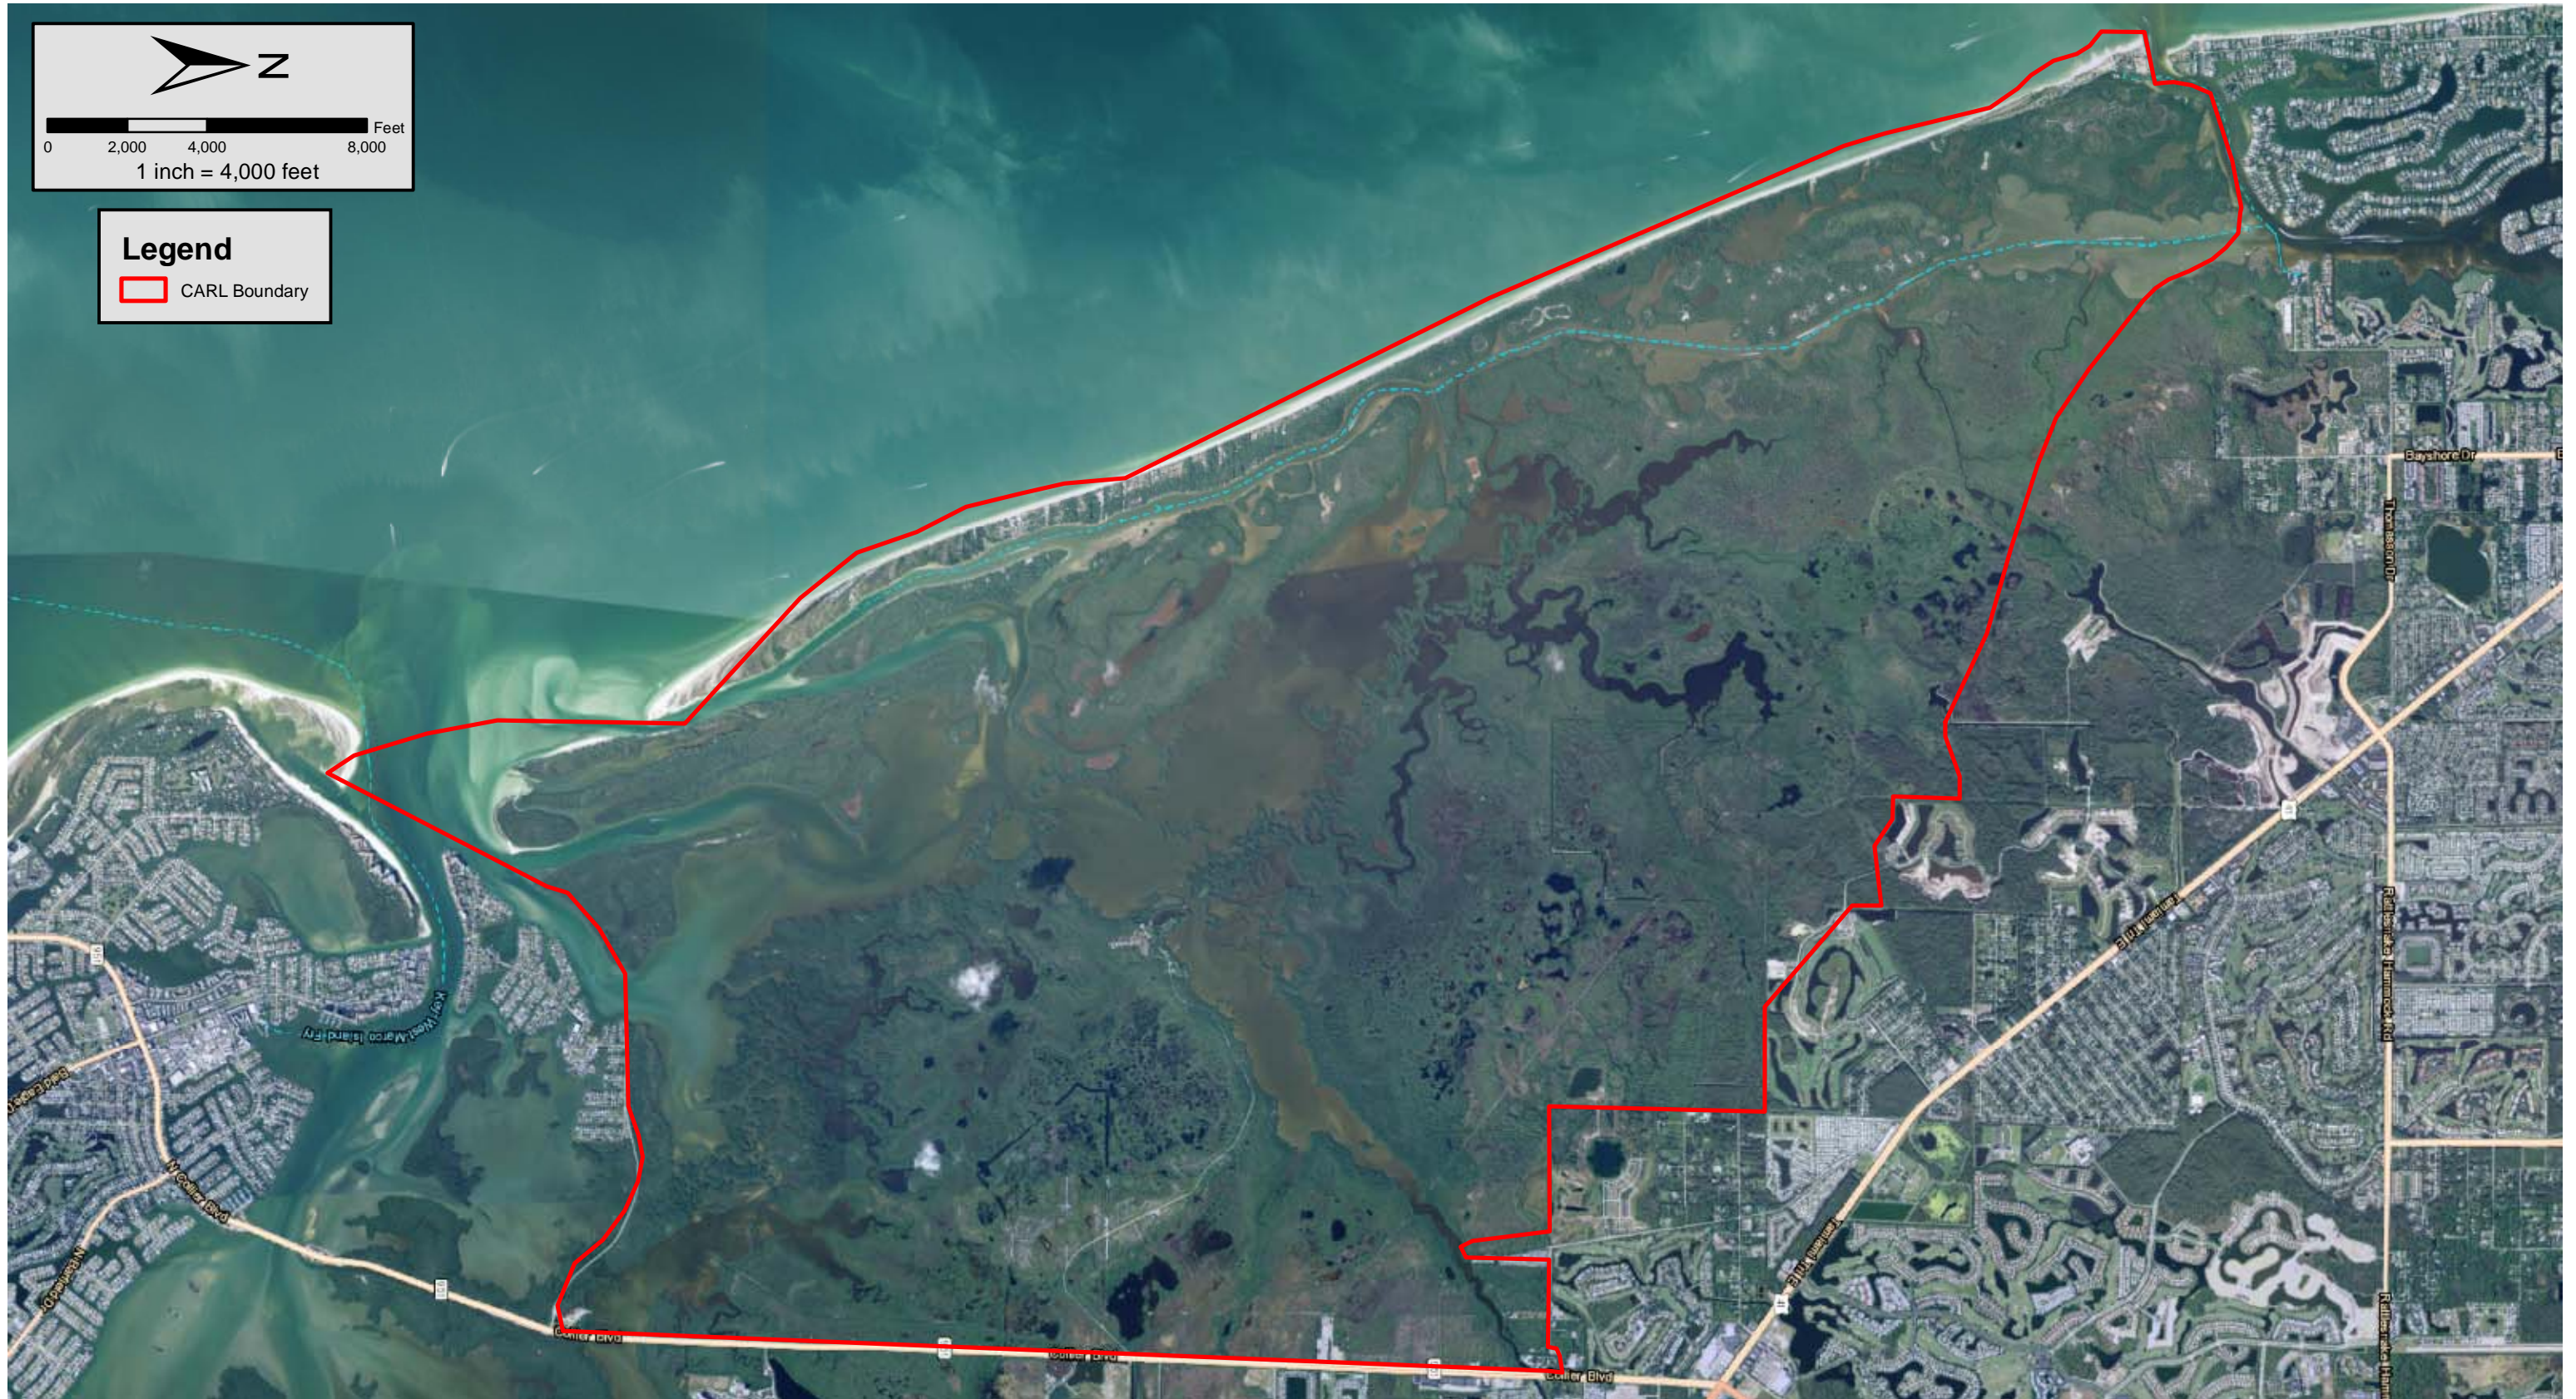
**Figure 2
CARL Boundary Map**

Rookery Bay
Collier County, Florida

- CARL Boundary
- Historical SAV Limits (988 Ac.)

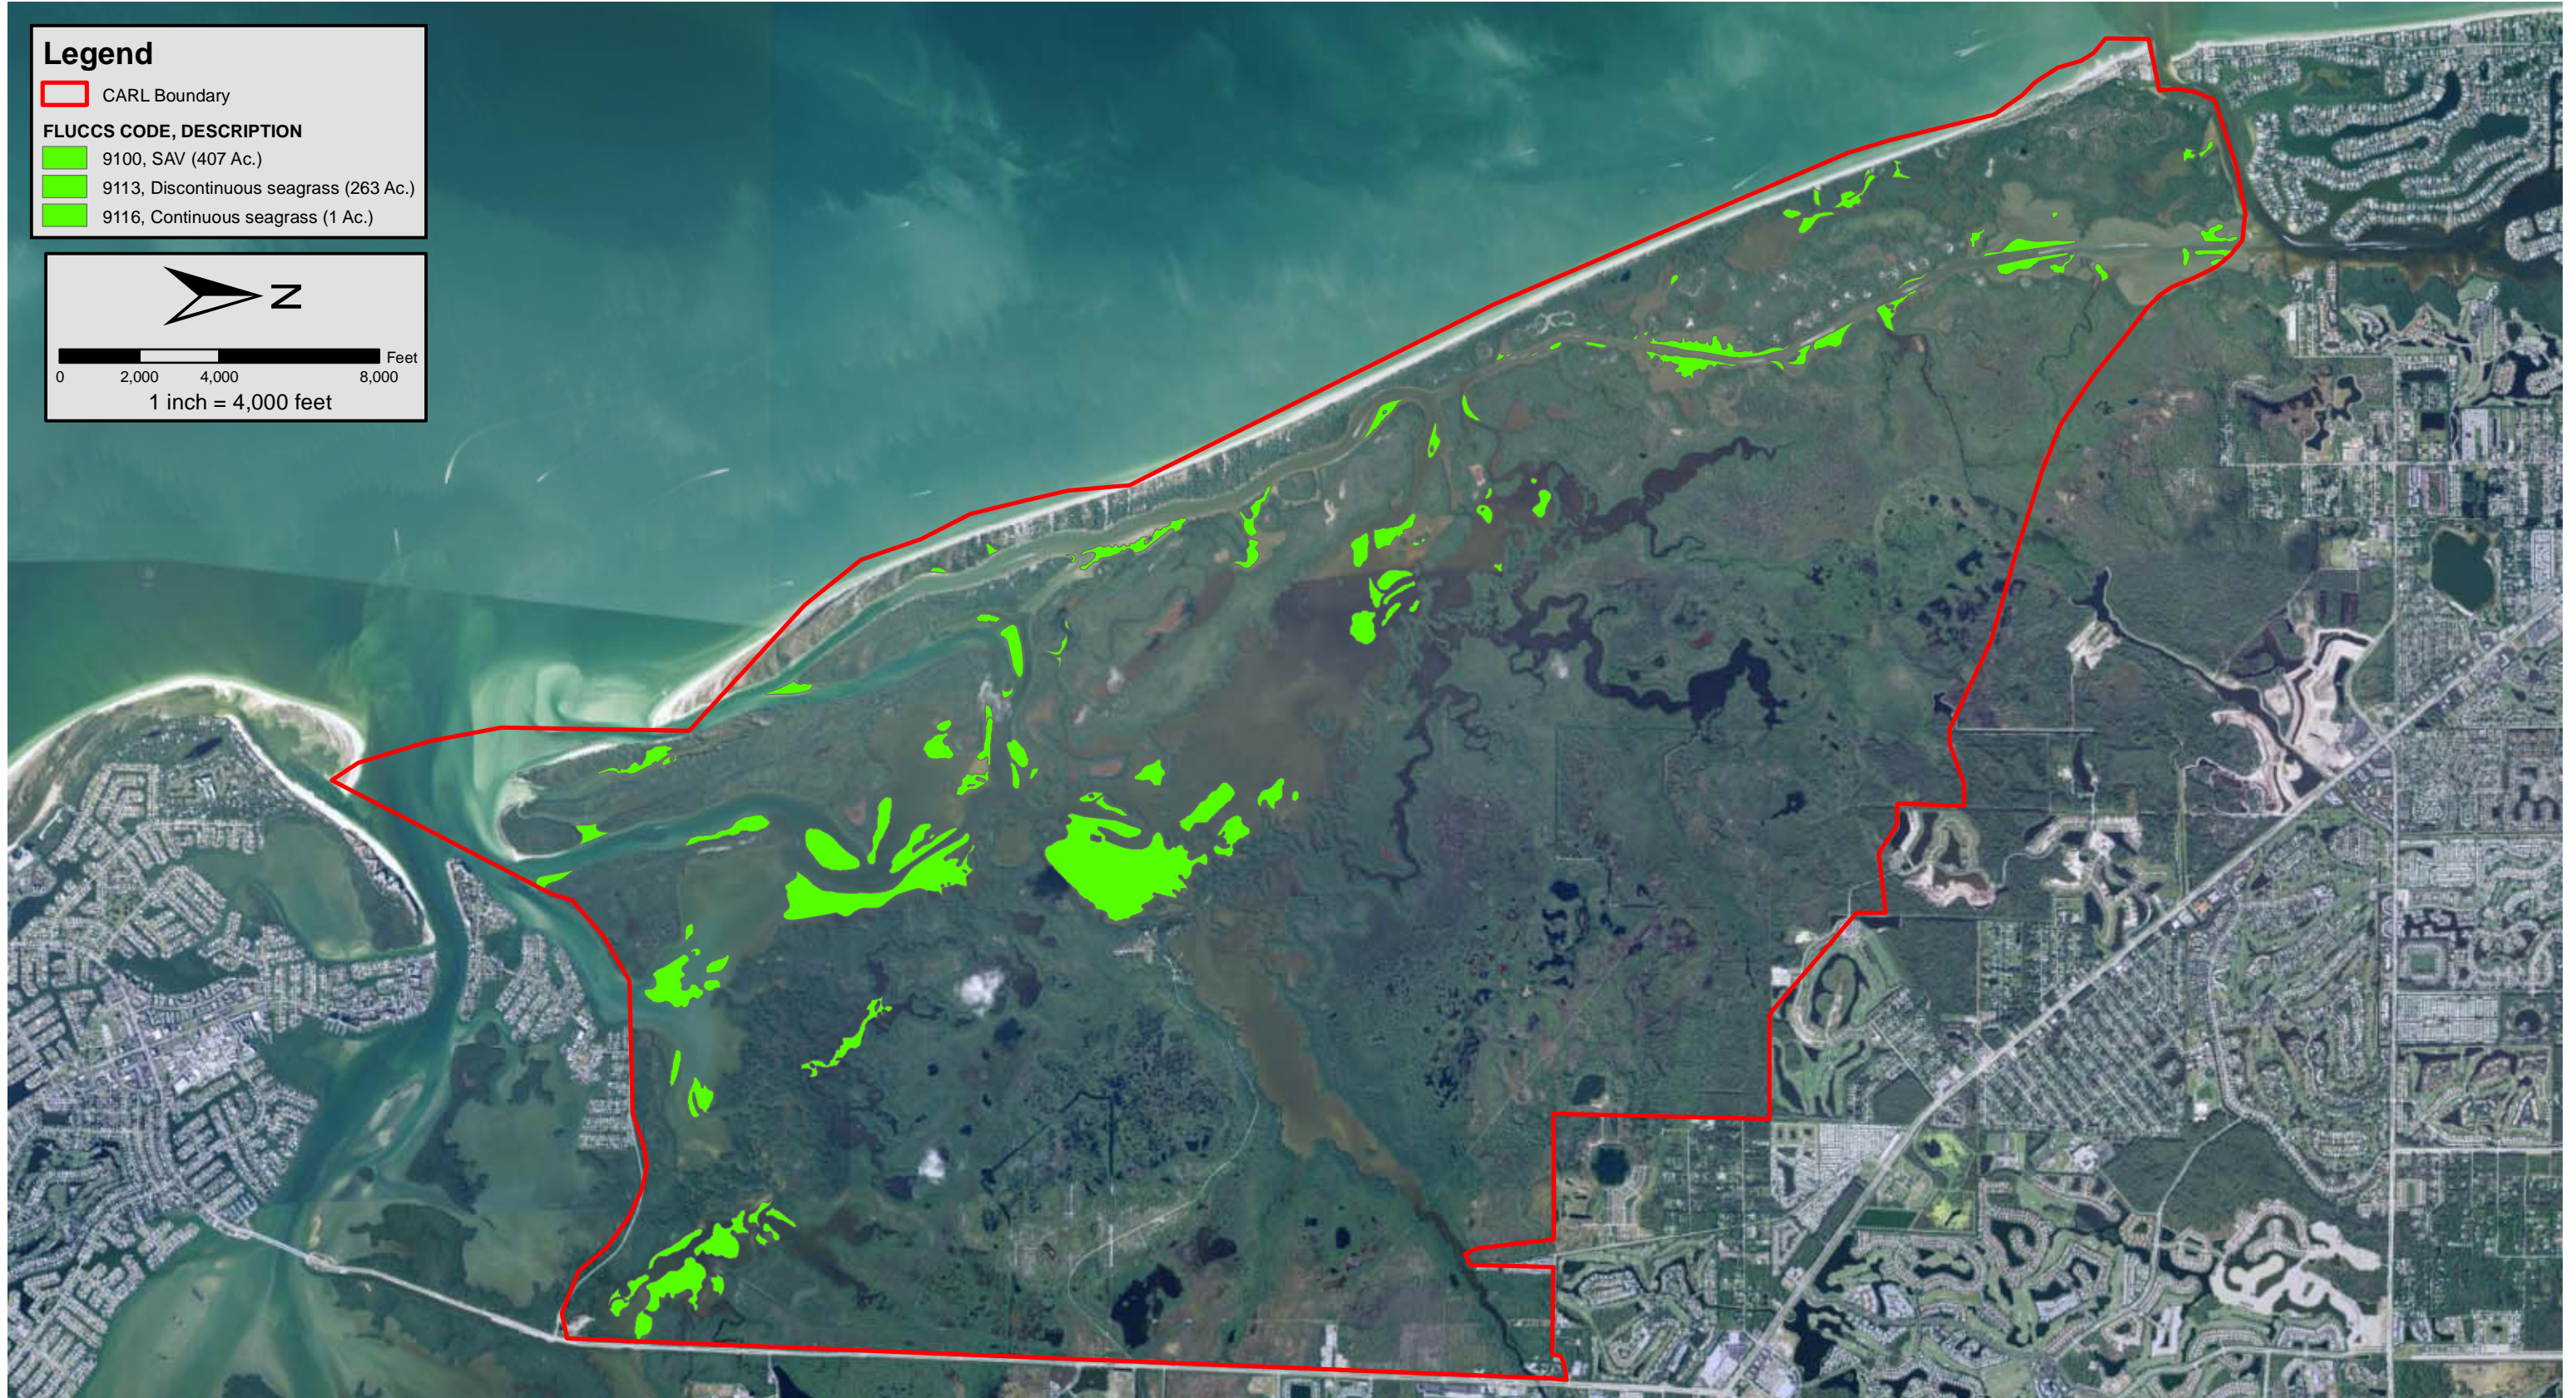
Figure 4
2014 Conditions SAV
Limits Map
Rookery Bay
Collier County, Florida

Legend

6510, Tidal Flats (4,326 Ac.)

6540, Oyster Beds (30 Ac.)

9100, SAV (407 Ac.)

9113, Discontinuous seagrass (263 Ac.)

9116, Continuous seagrass (1 Ac.)

The 2014 SAV and seagrass signatures (**Figure 4**) were combined, for comparison purposes to match the Historic Conditions map, and resulted in a combined total of 671 acres (Table 1).

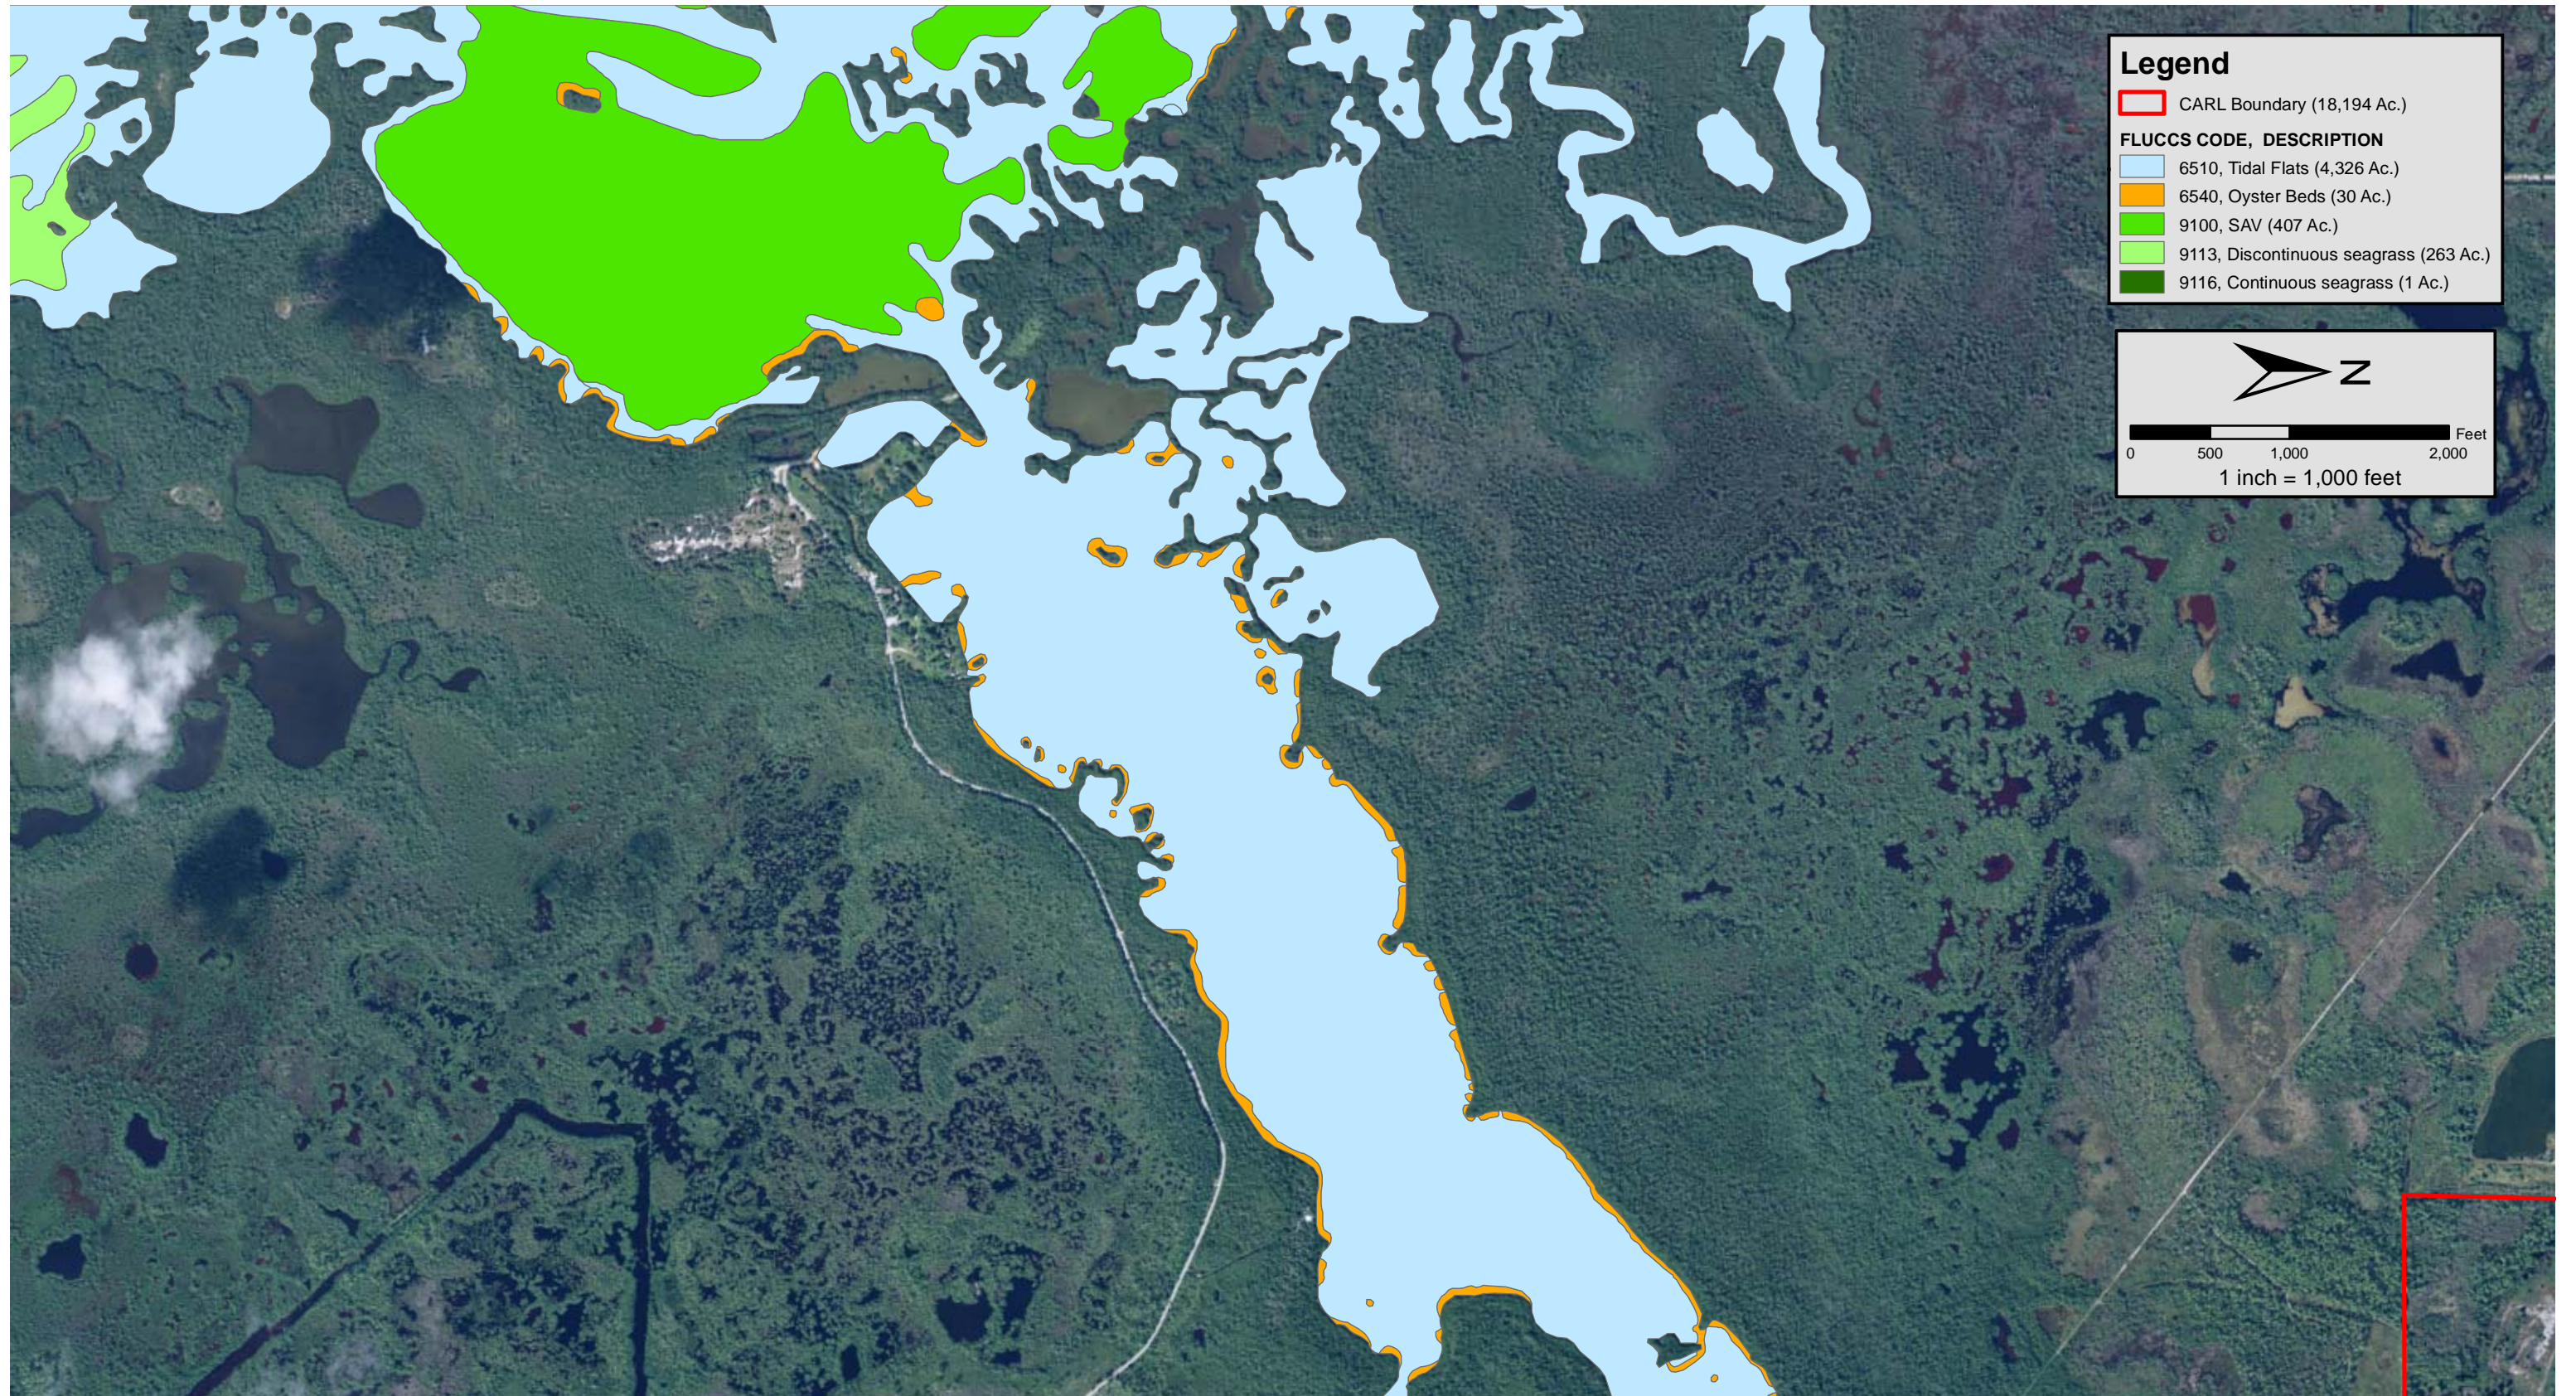
Figure 6
Henderson Creek
Resource Map
Rookery Bay
Collier County, Florida

CARL Boundary (18,194 Ac.)

6510, Tidal Flats (4,326 Ac.)

6540, Oyster Beds (30 Ac.)

9100, SAV (407 Ac.)

9113, Discontinuous seagrass (263 Ac.)

9116, Continuous seagrass (1 Ac.)

1 inch = 1,000 feet
