Restoring the Rookery Bay Estuary

A project connecting people and science for long-term community benefit

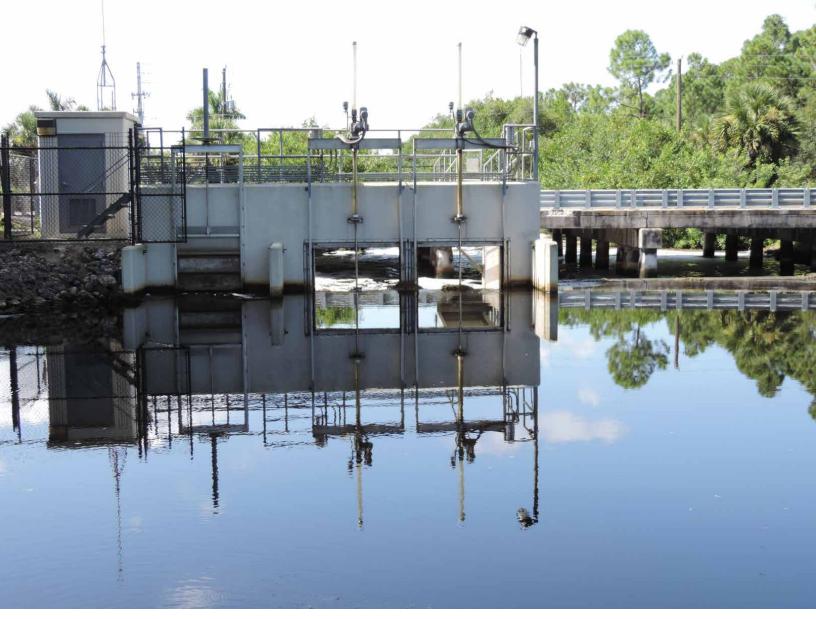
Current water management on Henderson Creek includes the opening and closing of a weir to control water flow.

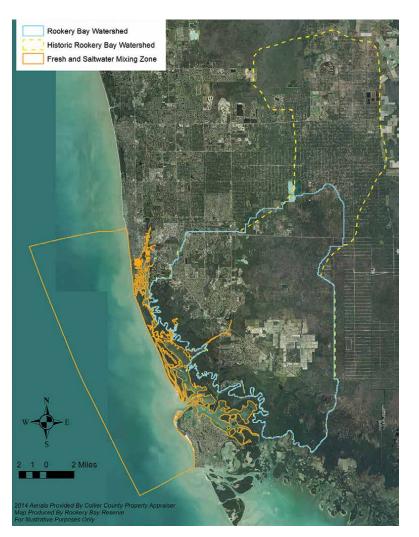
The historic watershed was 247 square miles of undeveloped wetlands that provided fresh water to the estuary through uninterrupted sheet flow. The 80 square mile difference between the current and historic size of the watershed was caused by the construction of roads, canals, and developments.

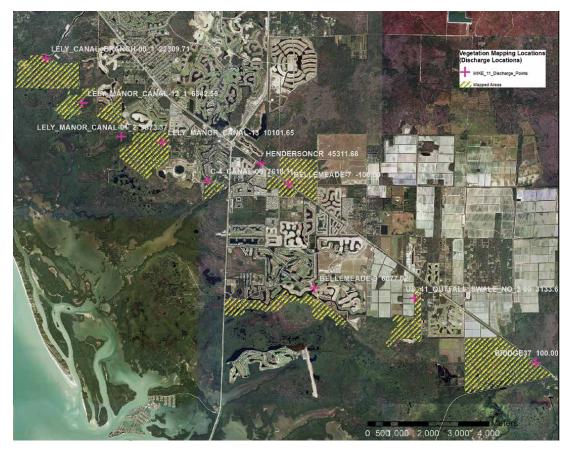
Freshwater discharge locations (shown) were mapped for current vegetation and then compared to historic vegetation through analysis of historic aerial images from the 1940s.

Throughout all the study sites, there were common changes that occurred between 1940 and 2010. In general, the study sites current conditions were more open and there was less woody vegetation than in 1940. This is most likely due to fire supression over the past 70 years, although some state owned lands (including RBNERR uplands) have developed prescribed fire programs. Fire promotes more open graminoid ecosystems, while a lack of fire encourages more shrubs and tree species. From 1940–2010 there has been approximately 23 centimeters of sea level rise with concomitant changes in freshwater sheet flow.¹⁴⁻¹⁶ Additionally, there have been large areas of direct clearing for development which were mapped as Human Impacted. Substantial invasive exotic plant infestations now occur in all areas. Full results can be found in: *Habitat Mapping and Trend Analyses: Rookery Bay Watershed Discharge Locations.*
