# Identifying changes in aquatic habitats

## Aquatic habitats are the foundation of a healthy estuary

## Restoring the Rookery Bay Estuary Project

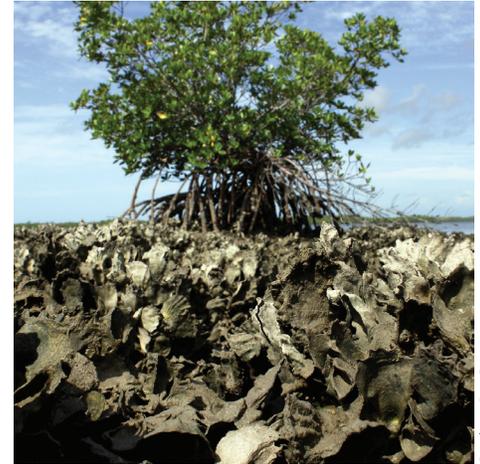
Top: Oyster reefs provide habitat for fish and other species and filter water throughout the estuary. Bottom: During the photo interpretation phase, researchers surveyed benthic habitats using a mask and snorkel, recorded their data, and video-taped underwater conditions.

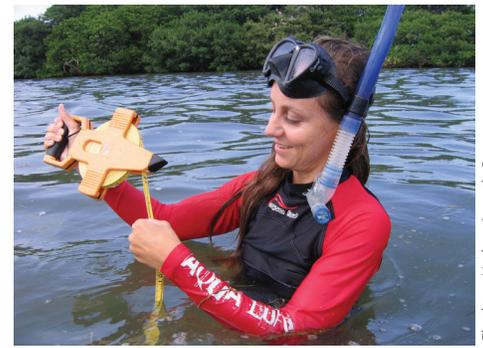
Top to bottom: Mapping of submerged habitats in Rookery Bay Reserve; addressing altered freshwater flows via restoration projects; stakeholder participation and education on altered flows and subsequent restoration activities.

**Conduct comprehensive mapping of submerged habitats in the Rookery Bay Reserve**, including species identification and on-going monitoring, to determine if management recommendations are effective in restoring lost habitats.
