# Restoring the Rookery Bay Estuary

through collaborative watershed management

# Restoring the Rookery Bay Estuary Project

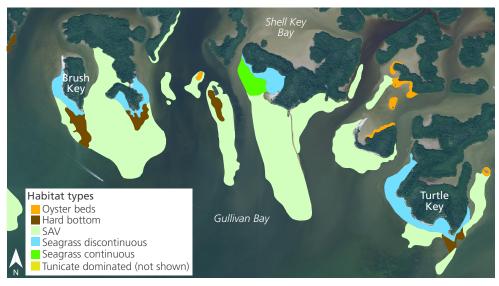
Results from mapping below-water habitats in the Ten Thousand Islands revealed six different habitat types present.

Aerial photos of the Rookery Bay Reserve, taken in December 2014, were interpreted by Scheda Ecological Associates and Taylor Engineering to identify submerged aquatic habitats. This data was compared to historical aerial photos that were assessed for habitat signatures with the goal of identifying habitat changes over an 85-year timeframe in the Rookery Bay estuary. Benthic, or bottom, habitat signatures included seagrass beds, algae, hard bottom, and oyster reefs. This effort represents a baseline of conditions which can be monitored over time to identify changes and possible causes that can be addressed through management.

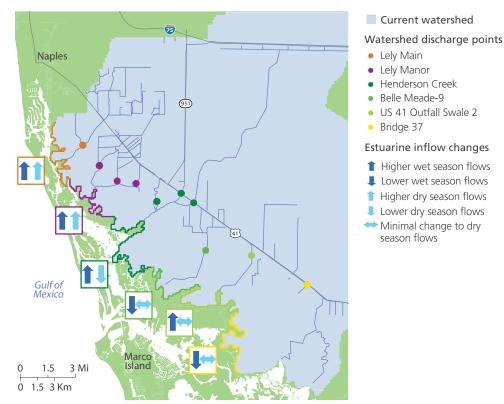
The historic watershed was 247 square miles of undeveloped wetlands that provided fresh water to the estuary through uninterrupted sheet flow. The current watershed is 167 square miles with ten freshwater discharge locations. The arrows (map above) show the changes in flow under current conditions when compared to historic conditions.

- When compared to historical model results, freshwater flows at all ten watershed discharge locations have been altered by the construction of canals, roads, and developments with varying effects on the timing and amount of water reaching the estuary.
- In areas with medium to dense residential development, current flows were greater than historical flows year round.
- Two sub-basins east of Henderson Creek typically showed water deficits, likely due to flow diversions into canals, or flow obstructions such as developments and roads.
